Pentium® II Processor Specification Update

Release Date: May 13, 1998

Order Number: 243337-014

The Pentium® II processor may contain design defects or errors known as errata which may cause the product to deviate from published specifications. Current characterized errata are documented in this Specification Update.

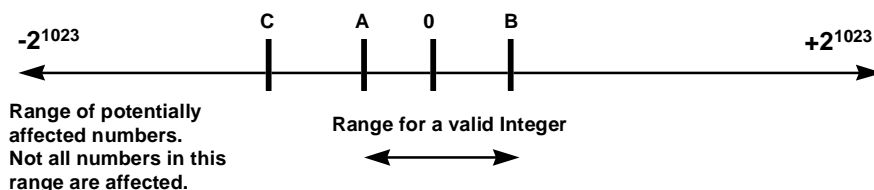
IMPLICATION: Erroneous operation results when the operand is so large that it will not fit into the target data size. The operands affected by this erratum are significantly outside (by a factor of 3X) the range that can be, correctly, converted to an integer value. The figure below and corresponding table identifies the normal range of integer numbers (between A and B) and the starting point of the operands affected by this erratum. Discrete failing operands will be present in the range between point C and the maximum negative number that can be represented by the processor (-2^{1023} in double precision format). Note 2 below gives a qualitative description of the nature of the discrete failing values. Software that does not rely on the Invalid Operation exception flag being set and signaled by either an exception OR by software polling is not impacted by this erratum.

16-bit Operation	A	B	C
	-32,768.0	+32,767.0	< -98304.0
32-bit Operation	A	B	C
	-2,147,483,648.0	+2,147,483,647.0	< -6,442,450,944.0

WORKAROUND: Any of two software workarounds will avoid occurrence of this erratum:

1. Range checking performed prior to execution of the FIST[P] instruction will prevent the overflow condition from occurring, and may already be implemented as a standard coding style.

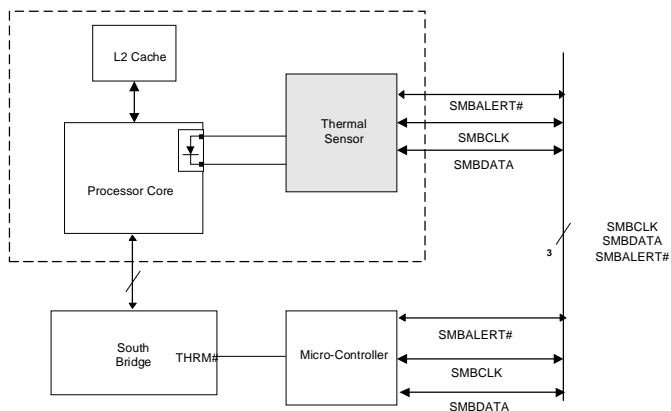
Figure 1. An Example of Micro-controller Driven Thermal Management

PROBLEM: The Mobile Pentium II processor and the Pentium II processor Mobile Module have a thermal sensor that monitors the processor core's temperature. Please note that desktop systems could have a similar thermal device. The thermal sensor asserts SMBALERT# if the processor temperature exceeds the temperature limits set in the Alarm Threshold Registers (T_{HIGH} , T_{LOW}). It also sets the corresponding Status Register bits to identify the cause of the interrupt. Figure 1 gives one example of the how the SMBALERT# signal could be used in a system.

Under the conditions described below, the thermal sensor incorrectly generates the SMBALERT# interrupt. *All* of the following conditions must be met to trigger a false interrupt:
